SIMSA MEMBER SPOTLIGHT:

Park Derochie Coatings

The Challenge

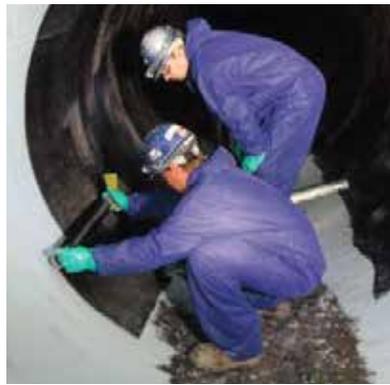
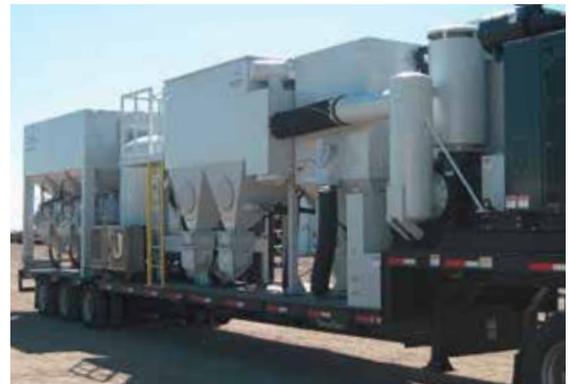
The #1 CW (cooling water) supply line at SaskPower's Boundary Dam Power Station draws water from its lake to reduce heat within the dam workings to within safe operating limits; without this cooling water, the station cannot operate, resulting in costly and far-reaching power provision problems. The CW supply line, a 6-foot diameter pipe, was deteriorating - a problem that reduced working pressures within the line to unacceptably low levels.

required specially trained teams working 24/7 for 47 days to complete. Logistics played a major role in the project, which included excavation work to unearth the pipe, robotic cleaning of the internal lines, pipe surface blasting, and application of the fiber-reinforced polymer liner.

Working 20 feet underground, certified Park Derochie teams sandblasted the pipe before applying the carbon fibre liner. Safety was the #1 priority throughout the process, with crews developing and adhering to strict confined space and emergency evacuation protocols. Rigid humidity and temperature conditions were also kept to ensure proper application of the coating.
